AIAA 2001-0838

Tunnel and Natural Icing Tests of a Helicopter Engine Cooling Bay Inlet

K. Al-Khalil and E. Irani

39th Aerospace Sciences Meeting & Exhibit

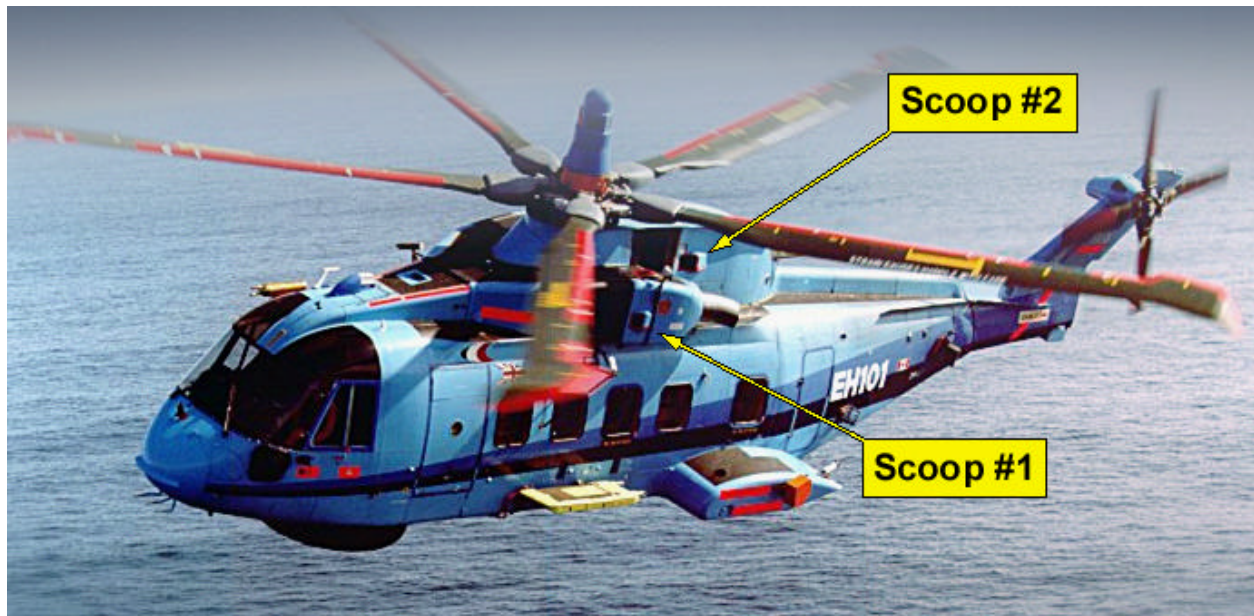
Figure 1: Location of Scoops on the GKN Westland Helicopter (EH101)
(Scoop 3 is symmetric to Scoop 1 on Starboard side)

This paper is concerned with the ice protection systems of the engine cooling bay scoops on the GKN Westland Helicopter EH101, shown in Figure 1. The aircraft is equipped with three engines: the No. 1 (Port) and the No. 3 (Starboard) are located symmetrically upfront, and the No. 2 (Center) is located on the left side of the aircraft, behind the No. 1 engine. There corresponds one scoop to each engine, the No. 1 and the No. 3 being identical. Reference to Scoops 1 and 3 will made interchangeably. Figure 1 shows the location of these scoops on the Helicopter. The scoops are mounted on the side of the aircraft cowling, downstream of each engine, to allow ram air into the bay for the purpose of cooling the engine. An engine-driven ejector controls the inlet airflow rate through each scoop.

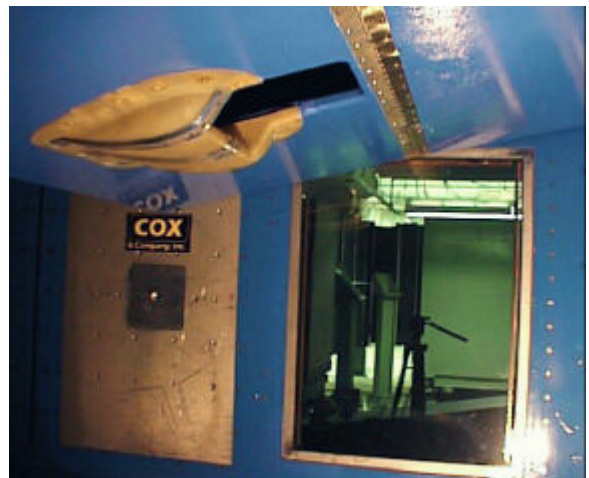
Figure 4: Scoop 1 tunnel setup in Test Section-2

The test setup of Scoops 1 and 2 were different as a result of their unique sizes, locations on the aircraft, and ice accretion shapes. Figure 4 is a side view image of the Scoop 1 setup on a modified tunnel ceiling. A ramp was formed on the ceiling following an angle to reproduce actual local airflow. The resulting scoop location was about 1 foot below the original ceiling. The added blockage also allowed a full airspeed of 120 KTAS to be simulated in Test Section-2. The scoop air inlet is connected through a plenum to the tunnel scavenger system to simulate the correct flow rate through the engine bay.

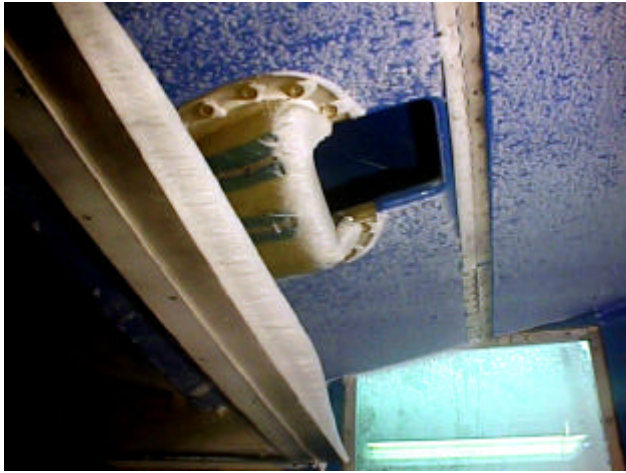
Figure 5: Cloud uniformity verification for Scoop 1 test setup

The validation procedure described in paragraph 2.0 was used successfully in the setup and validation tests for Scoop 1. For this scoop, an icing bar was also used to calibrate accretion in the vicinity of the scoop as shown in Figure 5. This figure also shows the cloud uniformity in the vicinity of the scoop. The LWC deficiency near the sidewalls has no impact on the scoop. It is a result of the lateral expansion in the diffuser section between the two test sections. Vertical cloud uniformity is closely maintained near the scoop.

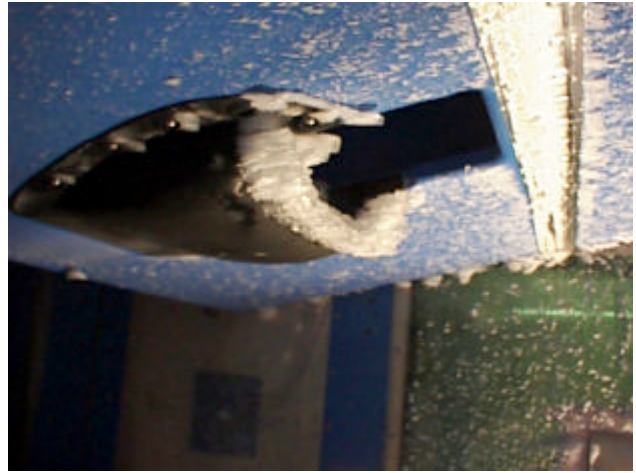
Figure 8: Glaze ice accretion and setup acceptance test for Scoop 1

Photographs of ice accretion on the forward Scoop 1 and Scoop 3 during the two flights chosen for the validation are illustrated in Figures 6 and 7. These correspond to the glaze and rime icing conditions, respectively. The corresponding ice shapes produced in the tunnel are shown in Figures 8 and 9 for the glaze condition, and Figure 10 for the rime condition.

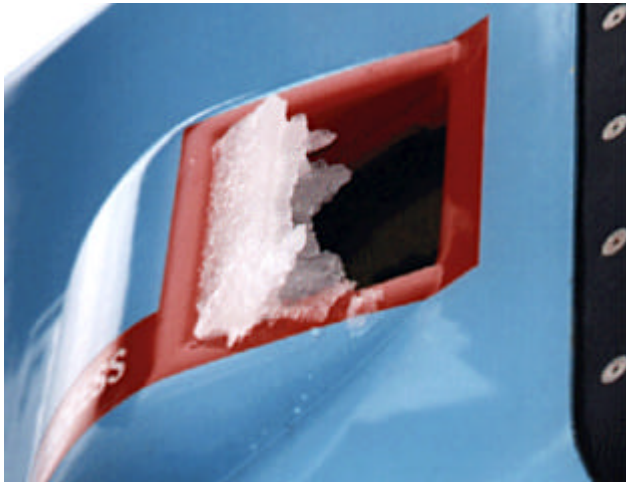
Figure 6: Glaze ice during flight on an earlier version of Scoop 1 (Flight 266)

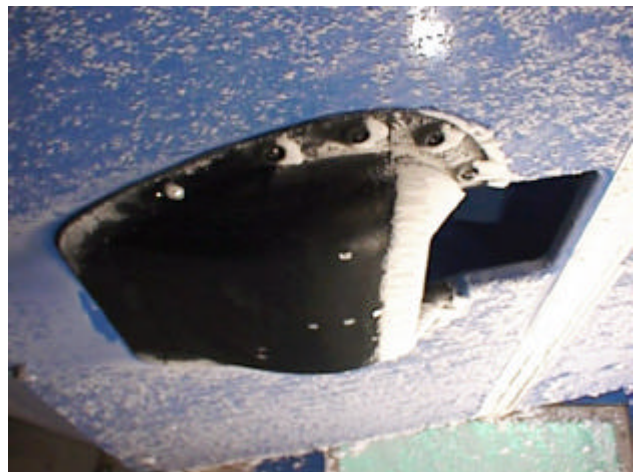
Figure 10: Rime ice accretion and setup acceptance test for Scoop 1

The main difference is the additional ice accretion obtained on the side buttresses in the tunnel versus the flight tests. The reason is that the current scoop geometry tested in the tunnel has front facing buttresses, which are at steeper angles relative to the freestream. The earlier version of Scoops 1 and 3 had buttresses that extended further upstream at a shallower angle relative to the freestream. However, both versions had exactly the same geometry near the centerline. Figure 9 shows the cross section of the ice accreted in the tunnel, which compares well with the corresponding flight ice shape shown in Figure 6 during glaze conditions. Also, Figure 10 shows that the ice thickness accreted on the hi-lite is nearly 1.1 inches which is very close to that observed during the rime condition of Flight 257 as seen in Figure 7.

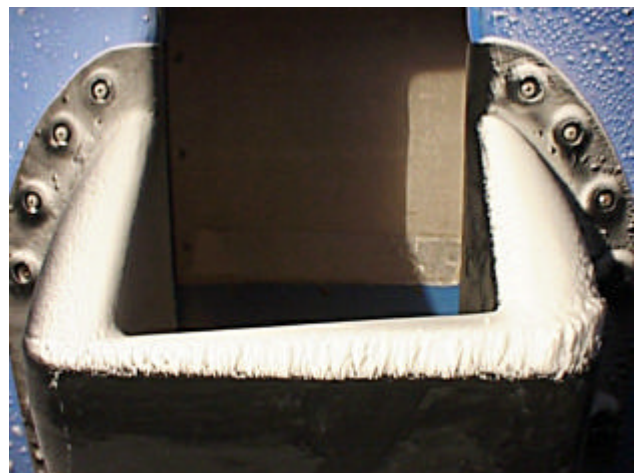
Figure 15: Rime ice on Scoop #2 with full size fairing (opposite effects seen in flight)

One of the clear disadvantages of this fairing was its relatively high blockage to the flow in the tunnel. Testing showed that little to no ice accreted on the fairing surface as a result of its good aerodynamic shape. The fairing resulted in an ice shape on Scoop 2 that was tapered in thickness as shown in Figure 15. Comparing that to Figure 11, the experimental ice shape was the reverse of that in flight. Basically, the fairing shadowed a portion of the scoop surface and produced a higher cloud density on the opposite side.

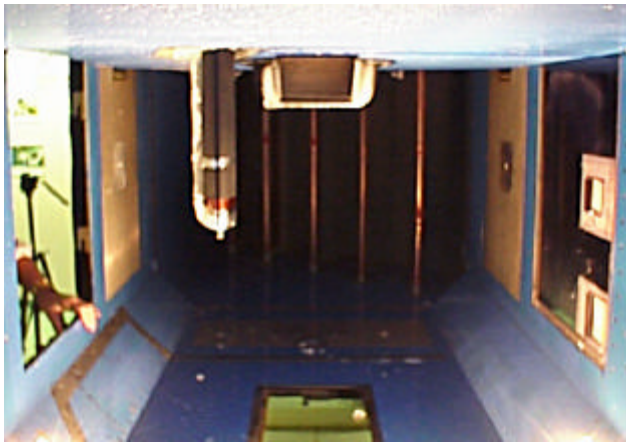
Figure 17: Downstream view of tunnel setup for Scoop 2 with airfoil flow deflector

shapes, as was the case, rendered during the earlier natural icing trials. The setup is similar to the one used for Scoop 1 with two exceptions: (1) the nozzles on the spray bars were relocated to produce high cloud water concentration on the lower side of Scoop 2 as observed during the flight trials; and, (2) the ramp consisted of two sections as with the fairing setup. The upstream section consisted of a ramp, and the downstream horizontal section held the scoop.

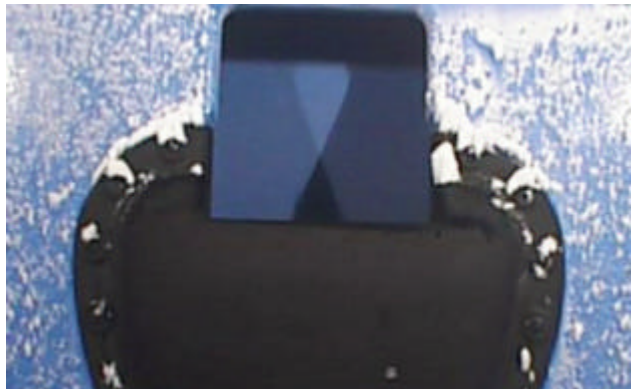
Test Point 2 (Figure 21)

This is a relatively cold condition case. Several helpful observations were made during this run. The flange was at about 25 °F most of the time. Little ice was observed to form on the buttress near the flange. This is a direct result of the fact that the bottom 0.5 inch of the buttsesses was unheated.

Another observation made was the ice growing forward (into the air stream) on the forward facing step of the flange upstream of the buttsesses. This phenomenon is thought to be attributable to the common tunnel wall icing effects due to the turbulent flow. The photographic data from the earlier icing trials did not show ice growth on the bottom of the buttsesses. However, the buttress heaters were extended towards the flange in the follow-up prototype flight scoops.

Figure 21: IPS performance in rime icing conditions (Scoop 1)

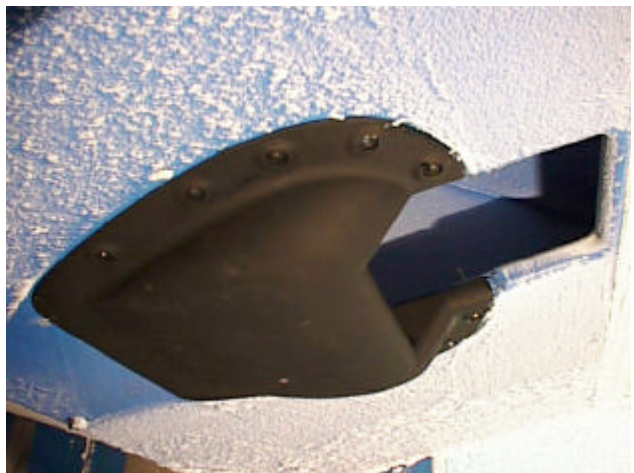
Test Point 3 (Figure 22)

This case is a Continuous Maximum (CM) icing condition with periodic incursions into Periodic Maximum (PM) icing conditions at a warm temperature and high LWC as required by the British DEF STAN. The PM conditions extend 6 Km (3.24 N.M.) horizontally. Despite the relatively cold temperatures, the scoop remained clear of any ice formation for the entire duration as shown in Figure 22. Surface wetness was observed to be limited to slightly past the direct impingement area.

Figure 22: IPS performance during rime and low speed conditions (Scoop 1)

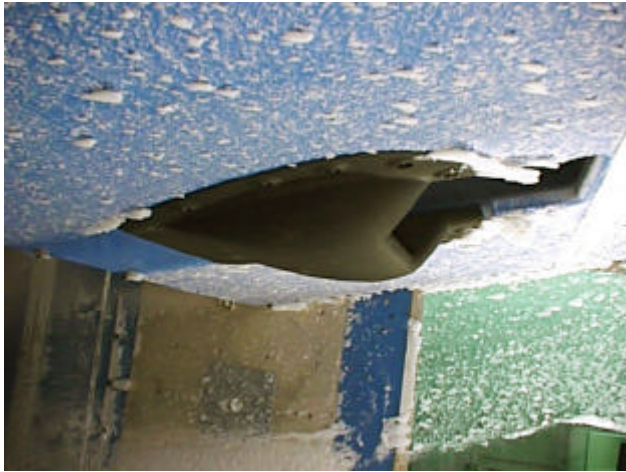
Test Point 4 (Figure 23)

This is a repeat of Test Point 3 but at a warmer condition. The flange temperature averaged +57 °F in the initial dry condition and +38 °F in the wet conditions.

The runback extended slightly beyond the direct impingement during the high LWC exposure of the Periodic Maximum conditions. There was no ice accumulation on the scoop surface except on the forward facing step of the flange. Again, this could be explained as being an artificial icing tunnel effect due to the flow turbulence.

Figure 23: IPS performance during alternate continuous and periodic maximum conditions (Scoop 1)

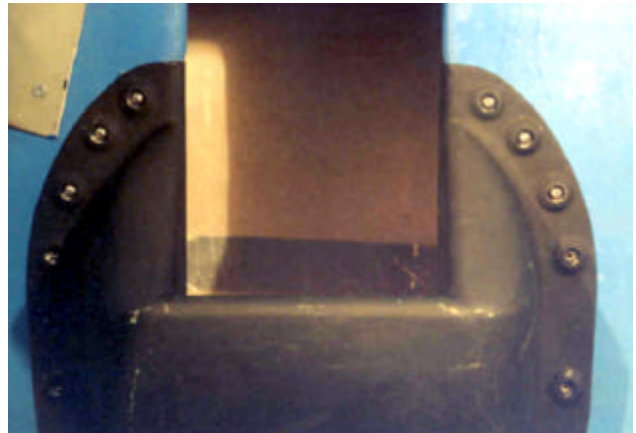
Test Point 8 (Figure 27)

The purpose of this run was to determine the effect of airspeed, 60 Kts in this case, on the SIPS anti-icing performance. The minimum tunnel calibrated LWC condition was used. Because of the low airspeed, the LWC was 1.74 g/m³. Despite this high LWC, the system performance was fully evaporative as shown in Figure 27 with no visible moisture on the surface.

Figure 27: IPS performance during low speed Intermittent Max conditions (Scoop 2)

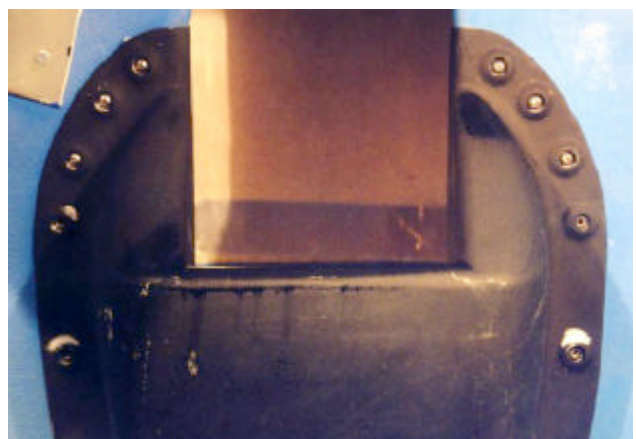
Test Point 9 (Figure 28)

Four full cycles of Intermittent Maximum condition were executed at the coldest temperature of -22 °F (-30 °C) in the test matrix. This particular Test Point turned out to be the determining design condition for Scoop 2.

Due to the high LWC condition (1.2 g/m³) at an extreme cold temperature, some runback was seen

beyond the heated zone in the direct impingement region. This is on the buttress side with the higher water catch as shown in Figures 11 and 19. The heater powers were as determined in the previous runs.

Figure 28: IPS performance during very cold Intermittent Max conditions (Scoop 2)

To remedy this problem, downstream heaters had to be activated with the rest of the heaters in the direct impingement zone. This required heating a large surface area. The trade-off is to increase the power density in the direct impingement zone and fully evaporate the water to prevent any runback flow to unheated downstream regions.

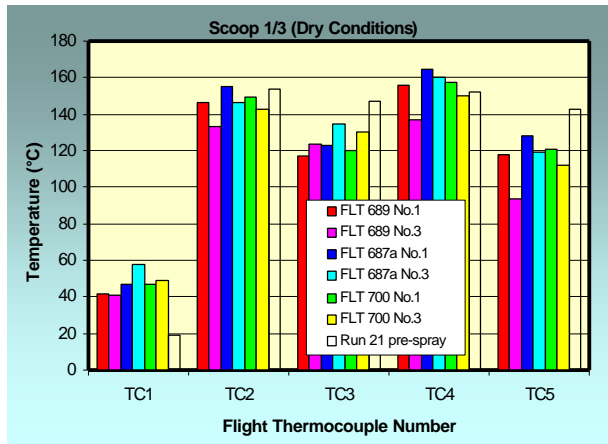
Figure 29 shows results of flight into dry air conditions for Scoops 1 and 3, compared to dry tunnel data. There is some variability within the flight data itself from flight to flight and between Scoop 1 and Scoop 3. With this in mind, the tunnel data (dark color) compares well with the flight data. It should be mentioned that the flange temperature TC1 was warmer in flight because the buttress heaters were extended closer to the flange in the flight units as a result of the tunnel observations of ice accretion close to the flange. However, flight video did not show that ice accreted close to the flange. This was suspected as tunnel turbulence may have caused the additional impingement. Also,

Figure 29: Tunnel and flight data comparison for Scoops 1 & 3 in dry air

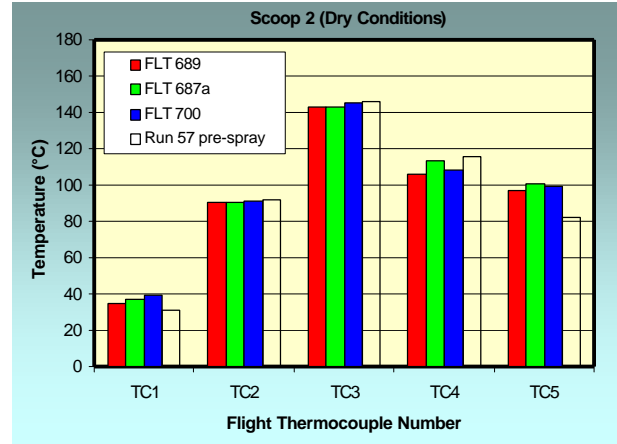
Table 5 shows the conditions corresponding to dry and wet conditions for Scoop 2. In the dry conditions, inflight ambient temperatures were within 3 °C of the tunnel test conditions of Run 57 prior to activating the spray system. The comparison between the different dry flight conditions and Run 57 is shown in Figure 31. Generally speaking, the agreement is very good between the flight and the tunnel data. The first thermocouple represents the temperature near the scoop flange at the base of the scoop buttress. There is some difference at the flange (TC1) and one of the downstream heaters (TC5). These differences could be due to differences in positioning of the sensors. The heater area corresponding to TC5 is large and the tunnel data model had two sensors (1 thermocouple and 1 RTD), which may not exactly correspond to the same location of TC5 on the flight unit. Nonetheless, the comparison is acceptable. Note that the flange temperature is less than 40 °C, which is well within the limit of 90 °C. This is typical of forward flight conditions.

Figure 31: Tunnel and flight data comparison for Scoop 2 in dry air

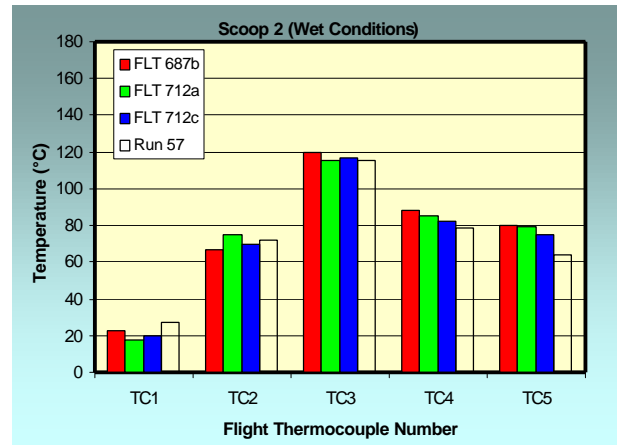
Figure 32 shows comparisons for Scoop 2 in wet conditions. Here, the flight OAT is within 2 °C of the tunnel case. The LWC is high in all conditions and relatively close to the tunnel value with the exception of Flight condition 687b, which is 0.6 compared to 0.87 g/m³ tunnel value. However, Figure 32 shows that thermocouple data from that flight are a little colder than the other flights despite their being at a slightly warmer OAT and lower LWC. This indicates that there are some variations and uncertainties in the flight data. The tunnel data in Figure 32 seems to be within this variability, which indicates very good correlation with flight data.

Figure 32: Tunnel and flight data comparison for Scoop 2 in wet conditions
